Manhole Inspection Summary

Manhole # S4100_001MH

Location Address: **1100 BONOPARTE AVE**

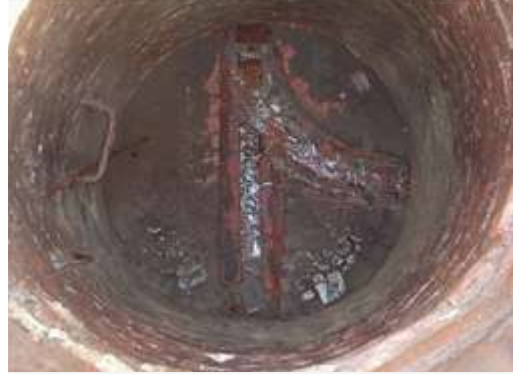
Top View

☒ **Corroded**

☒ **Evidence Of Surcharge**

Corroded and missing steps. Evidence of surcharge - Bench debris.

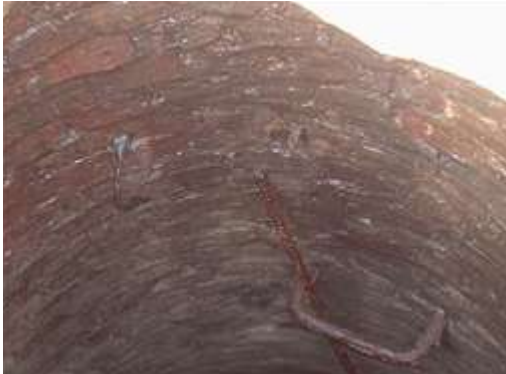
Defect

Condition: ☐ Sound ☐ Cracked ☐ Root Intrusion ☐ Loose Brick ☒ **Deteriorated**

Adjustment and Corbel deterioration and infiltration.

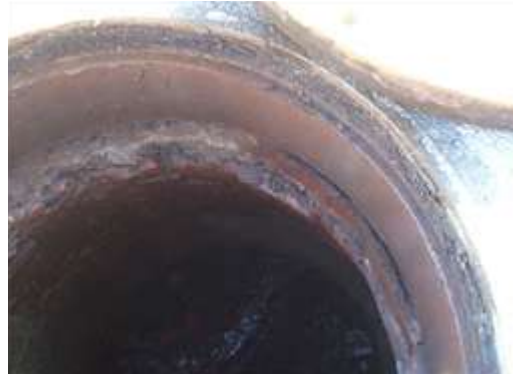
Defect

☒ **Leaks**

Frame leaks. Frame offset. Adjustment deterioration and infiltration.

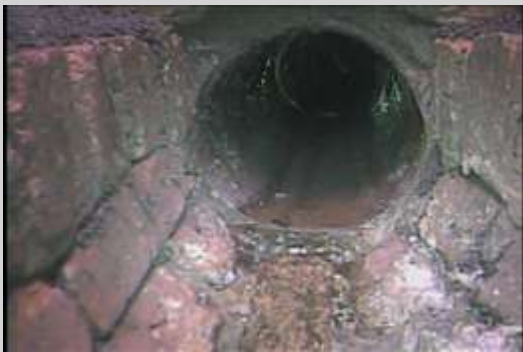
8 in. Circular Gravity Sewer Pipe Out @ 12 O'Clock

Channel deterioration.

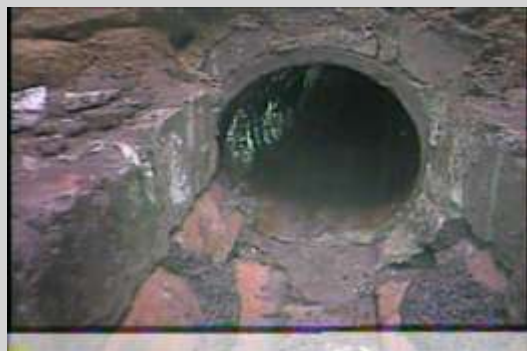
Pipe In @ 6 O'Clock

Channel root intrusion.
